USAAEFA PROJECT NO. 80-17-2

**AIRWORTHINESS AND  
FLIGHT CHARACTERISTICS TEST PART 2  
YAH-64 ADVANCED ATTACK HELICOPTER**

FINAL REPORT

FEBRUARY 1982

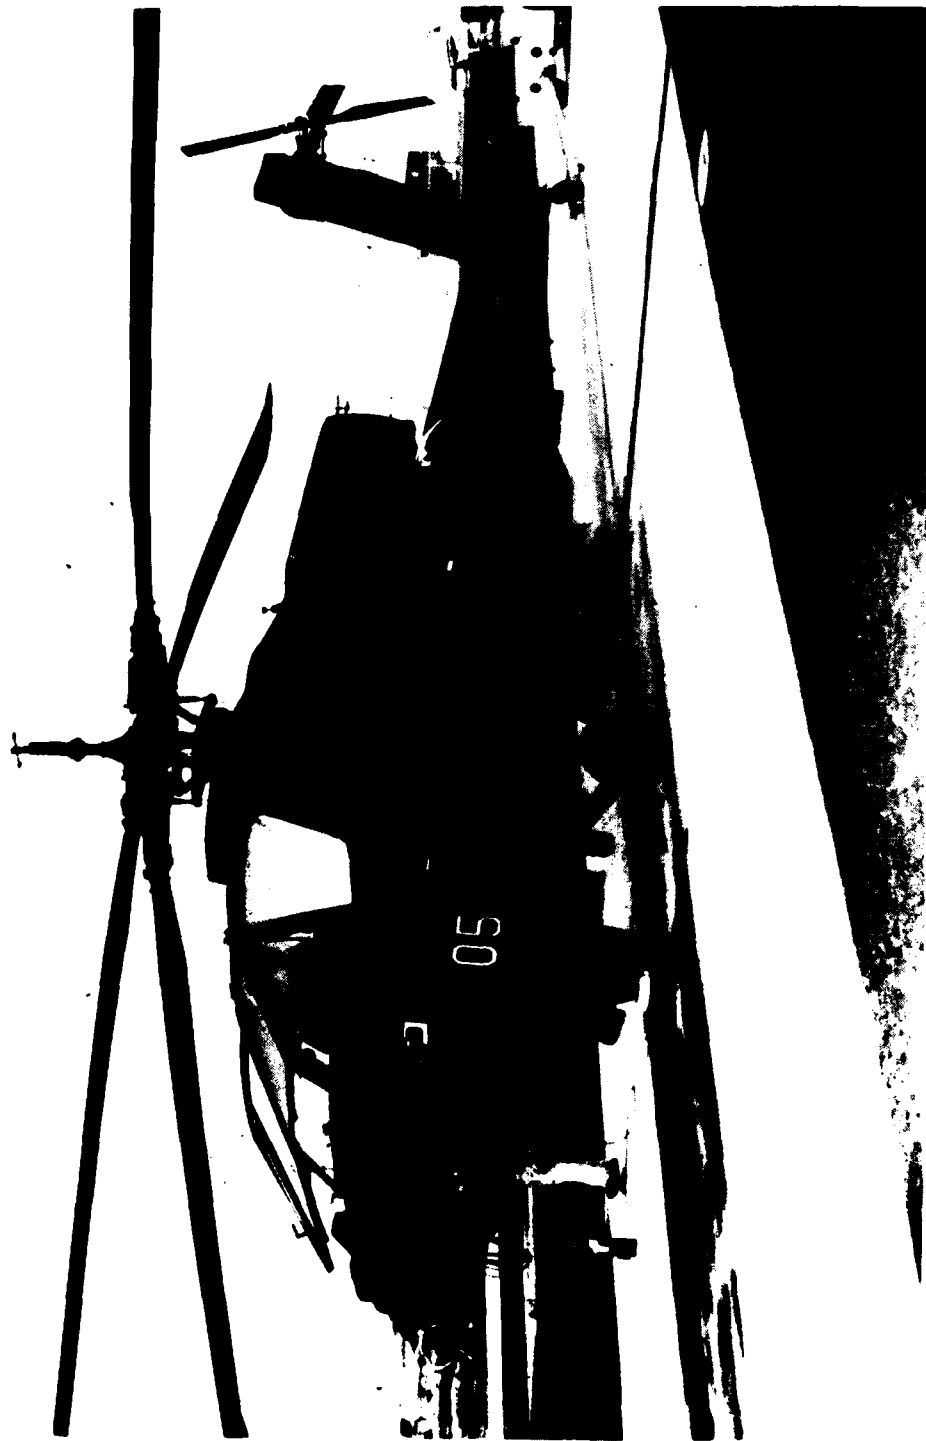
Photo 1. IMC Curtain Installation (exterior)

20. A limited IMC evaluation was performed and consisted of a single flight conducted in smooth air. Maneuvers performed included climbs, descents, climbing and descending turns, tracking, simulated approaches and instrument take-offs. The normal mode of operation for IMC flight was with DASE ON and Attitude Hold ON. Operation with either DASE ON and Attitude Hold OFF or with DASE OFF was considered to be a degraded mode. IMC conditions were simulated by the installation of white curtains in the pilot station as shown in photos 1 and 2. All available flight instruments were used including the Electronic Attitude Direction Indicator. Turn rate indication was not available as both turn needles were inoperative. Navigation and instrument approaches were done using doppler way points as simulated Automatic Direction Finding stations. The flight instruments are shown in photo 3. The PNVS was not operational during this test. For this flight only, the ship's airspeed was connected to the pilot airspeed indicator. Maneuvers were flown DASE ON with the Attitude Hold both ON and OFF and with DASE OFF.

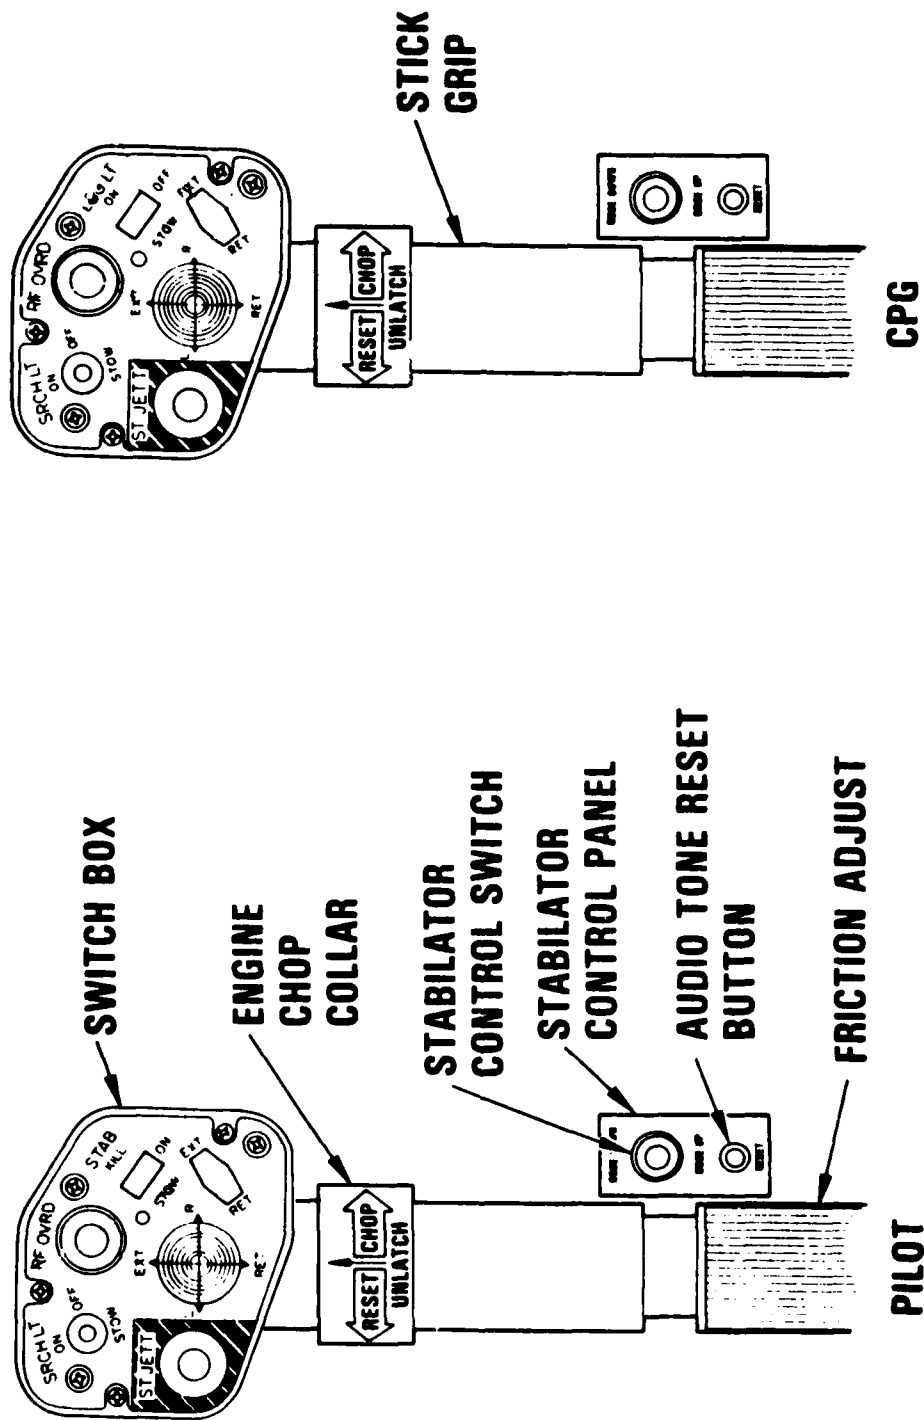
Figure 7. Collective Stick and Switch Box

5. Each collective stick (fig. 7) incorporates a switch box assembly, an engine chop collar, a stabilator control panel and an adjustable friction control. The engine chop collar allows rapid deceleration of both engines to flight idle, primarily to allow immediate action in the event of a tail rotor failure.

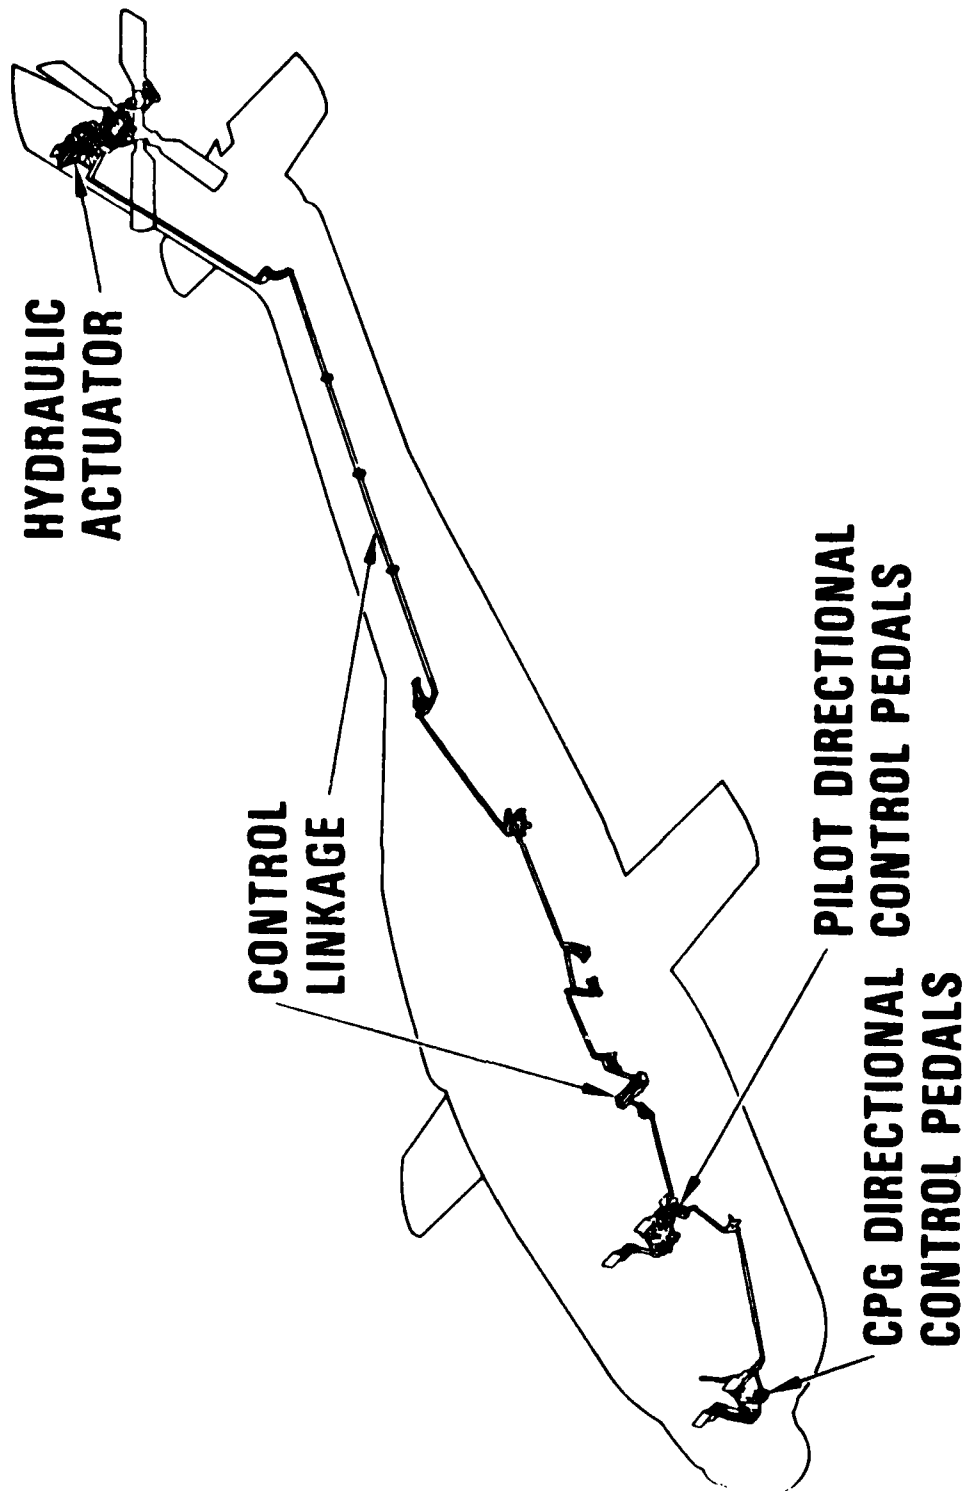
Figure 8. Directional Controls

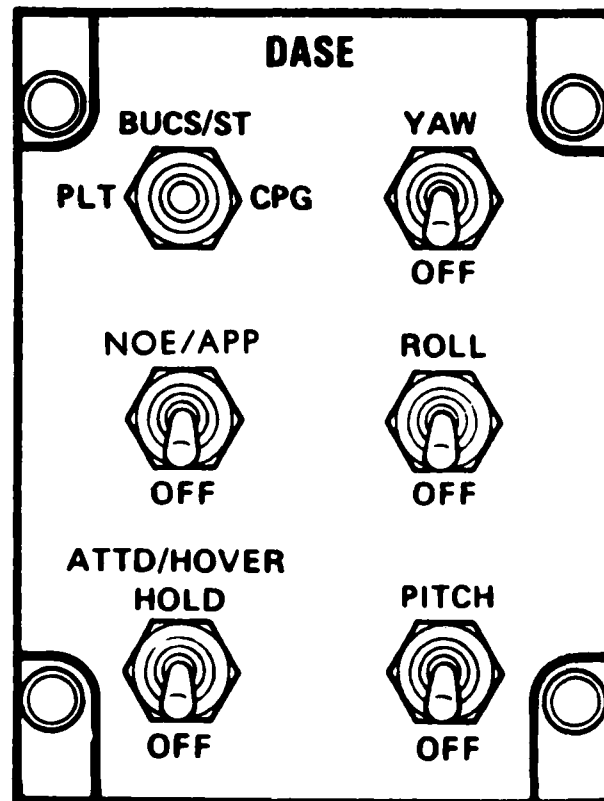
Figure 11. DASE Control Panel

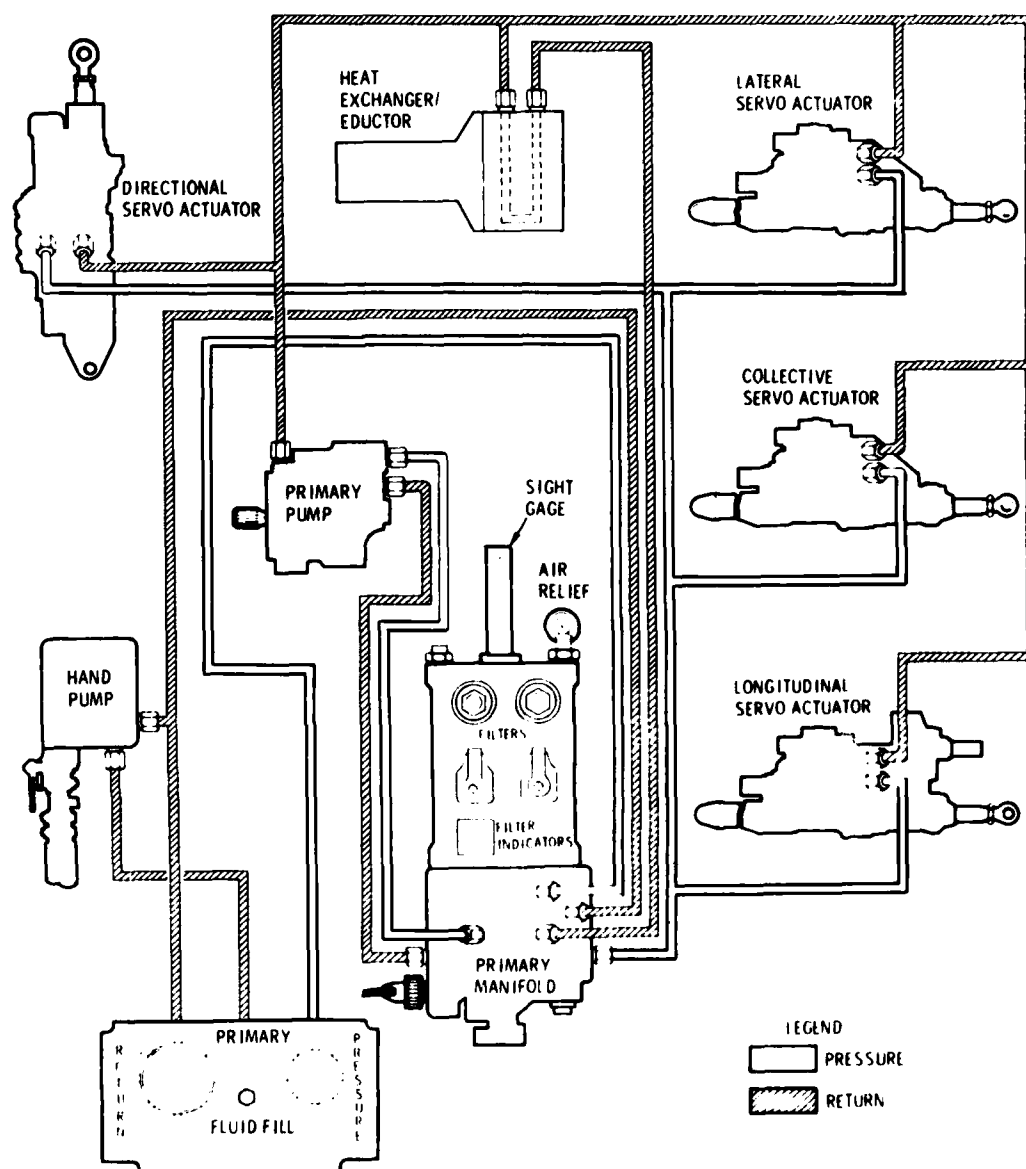
19. The hydraulic system consists of four hydraulic servoactuators powered simultaneously by two independent 3000-psi hydraulic systems. Each servoactuator simultaneously receives pressure from the primary and utility systems to drive the dual-tandem actuators. This design allows the remaining system to automatically continue powering the servos in the event of a single hydraulic system failure. The two systems (primary and utility) are driven by the accessory gearbox utilizing variable displacement pumps, independent reservoirs and accumulators. The APU drives all accessories, including the hydraulic pumps, when the aircraft is on the ground and the rotors are not turning. The accessory gearbox is driven by the main transmission during flight and provides for normal operation of both hydraulic systems during

Figure 12. Primary Hydraulic System

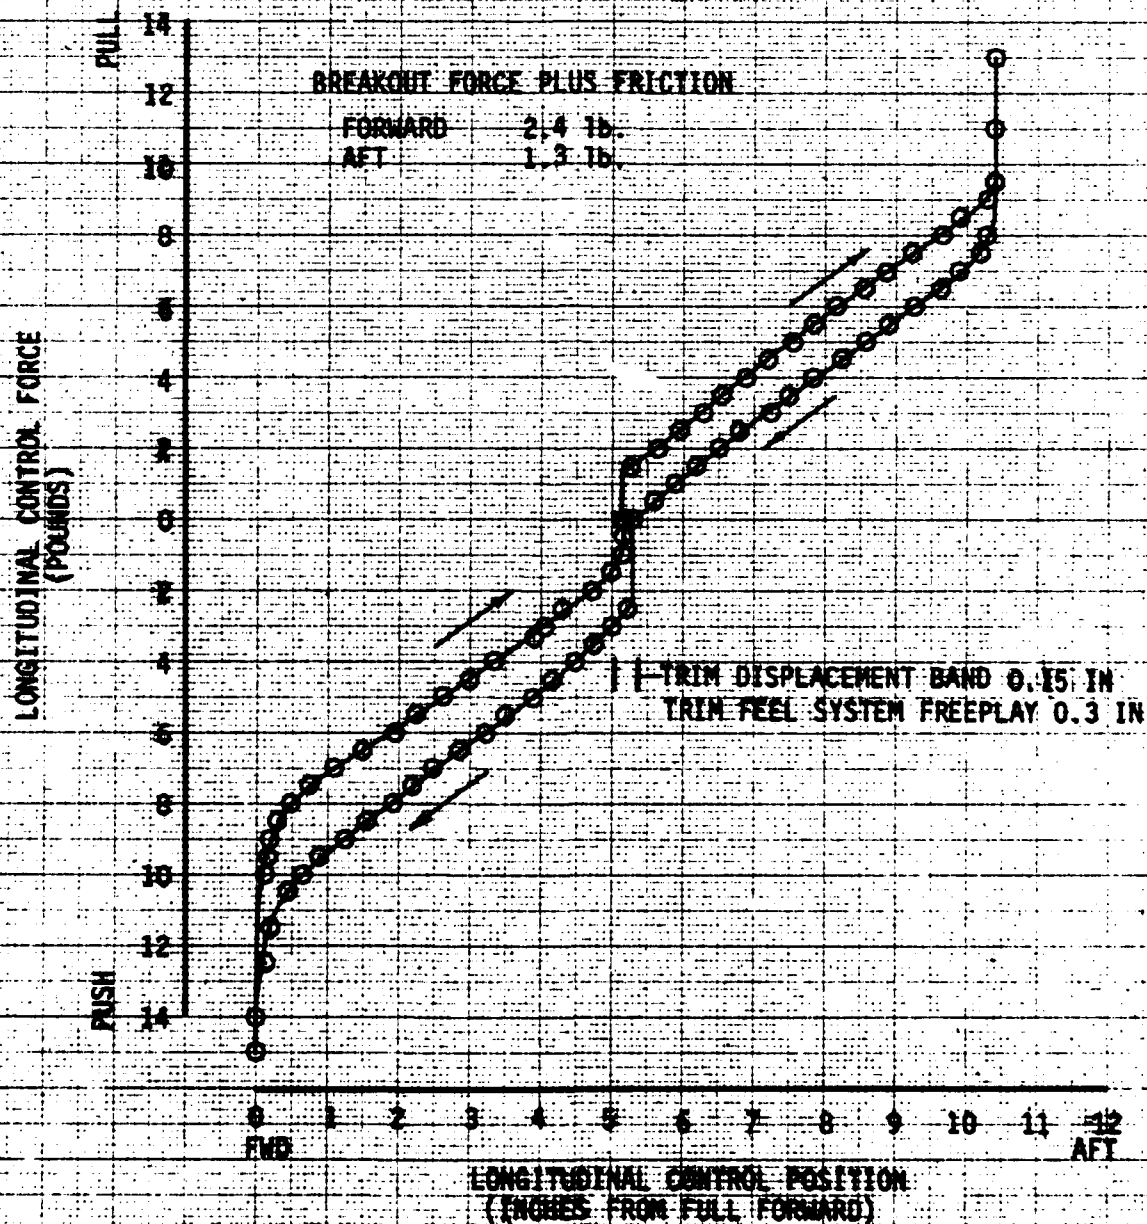
- NOTES:
1. ROTORS STATIC
  2. FORCES AND POSITIONS MEASURED AT CENTER OF GRIP
  3. HYDRAULIC AND ELECTRICAL POWER PROVIDED BY GROUND POWER UNITS
  4. COPILOT/GUNNER CYCLIC CONTROL EXTENDED
  5. TRIM FEEL ON
  6. TOTAL LONGITUDINAL CONTROL TRAVEL = 10.4 INCHES

FIGURE 4  
LONGITUDINAL CONTROL SYSTEM CHARACTERISTICS  
YAM-64 USA S/N 77-23258

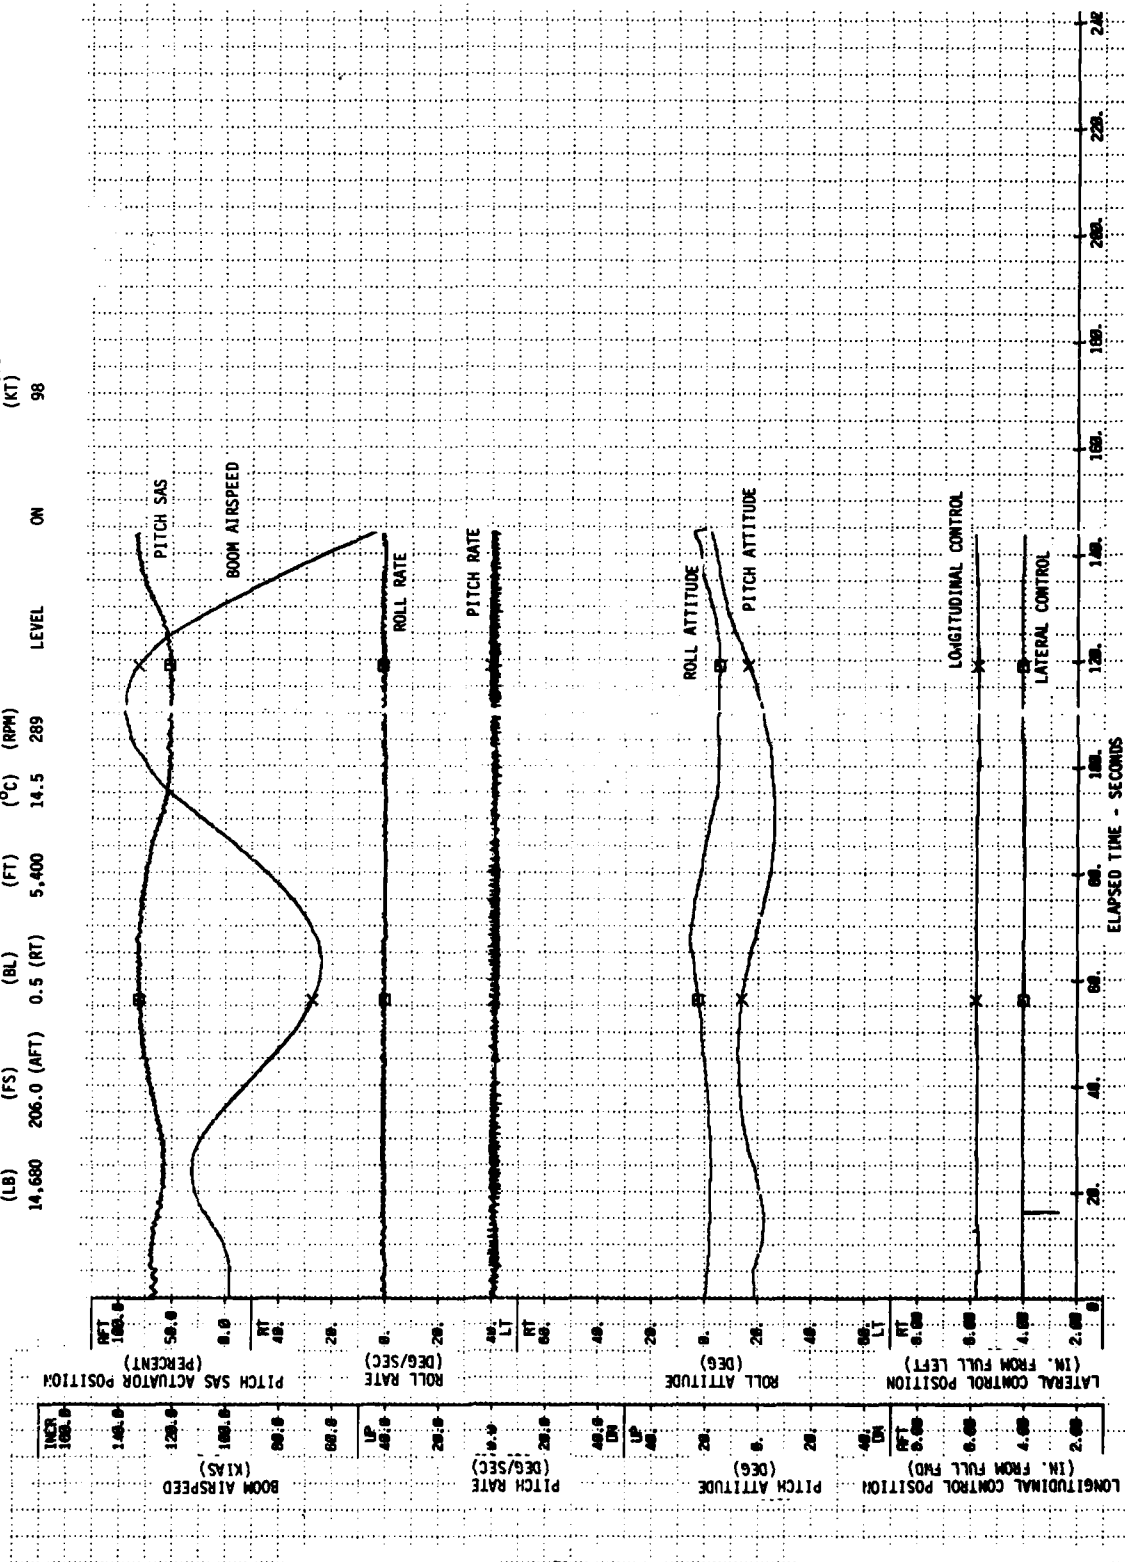
**FIGURE 16**  
**LONGITUDINAL CONTROLLABILITY**  
**YAH-64 USA S/N 77-23258**

17. The longitudinal control response, at 100 KCAS (fig. 16) was 11.5 degrees/sec/in. for forward and aft inputs DASE ON and OFF. Control sensitivity was greater with DASE ON (17 degrees/sec<sup>2</sup>/in.) than DASE OFF (10 degrees/sec<sup>2</sup>/in.) and the time to reach 63 percent of maximum pitch rate was 0.5 sec with DASE ON and 1.1 sec with DASE OFF. Aircraft response was rapid and no handling qualities problems were observed. The longitudinal controllability characteristics are satisfactory.

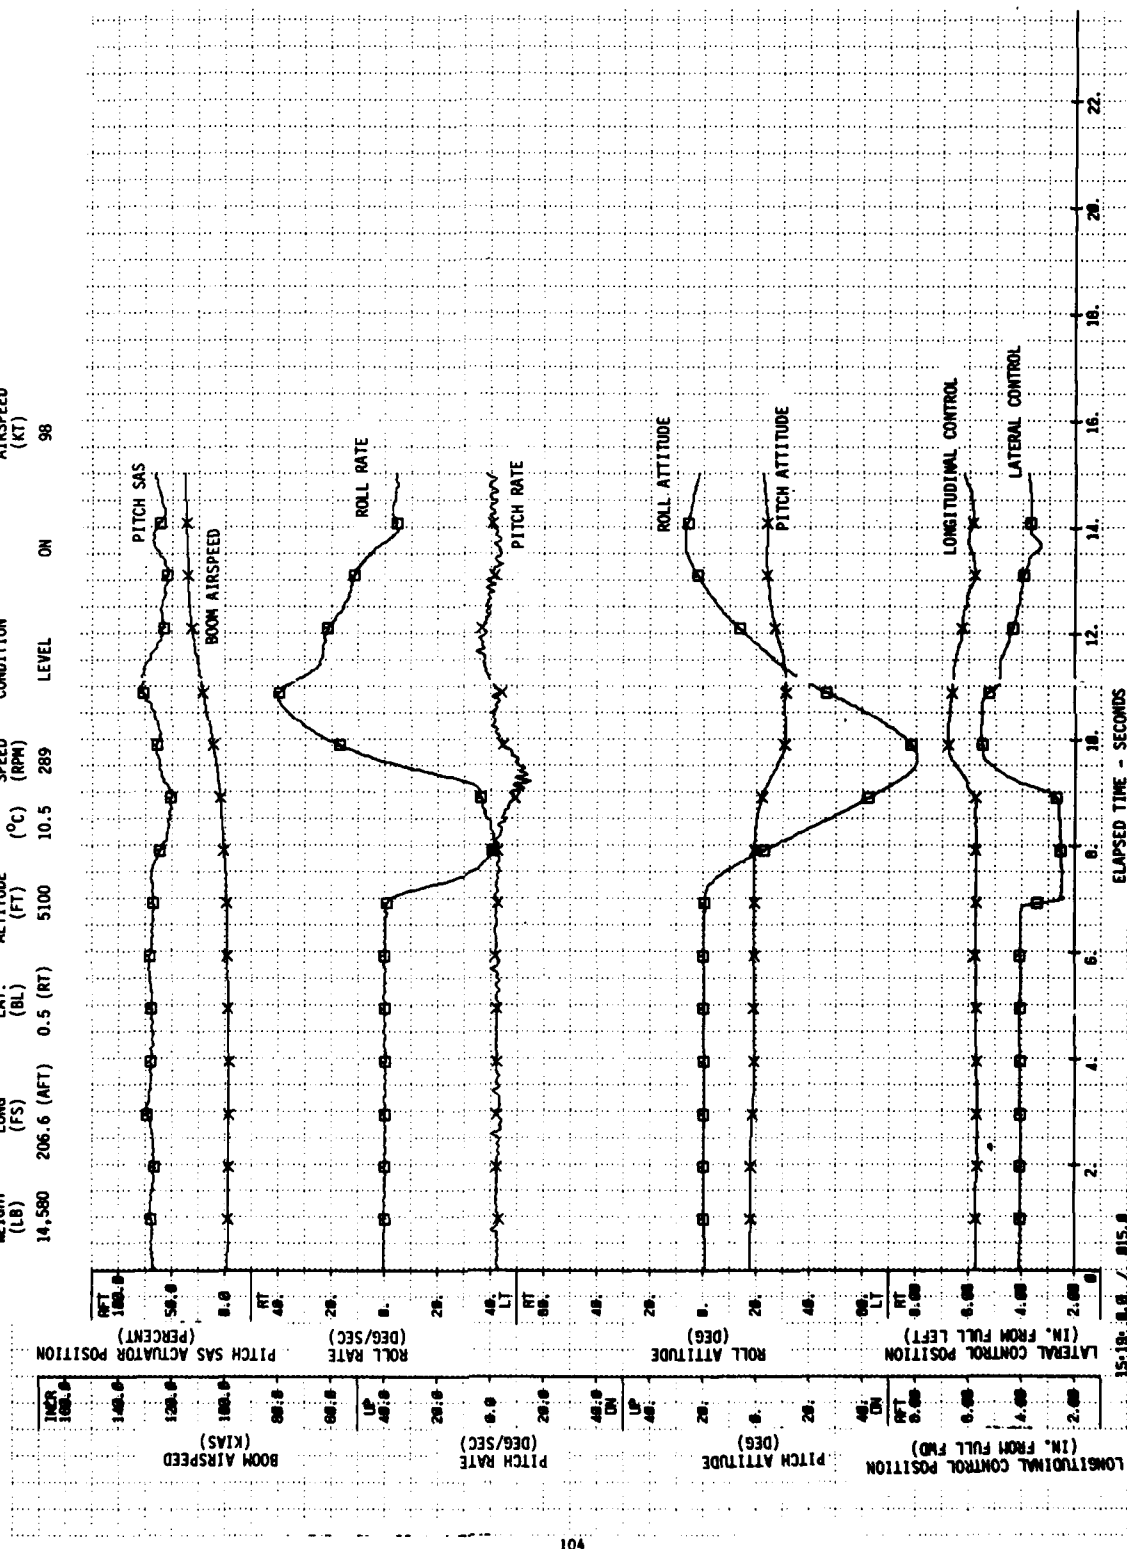
FIGURE 22  
AIRCRAFT RESPONSE TO HAS ENGAGEMENT  
YAH-64 USA S/N 77-23258

32. The Hover Augmentation System (HAS) was evaluated in a stabilized hover, a bob up, and while repositioning with and without retrimming. No abrupt aircraft responses were noted, however, divergent pitch and roll oscillations were observed (fig. 22, app E). The period of both oscillations was approximately 11 seconds. The pilot was required to make continuous longitudinal control inputs, in order to damp the oscillations and could not safely remove his hand from the cyclic. The divergent pitch and roll oscillations, while hovering with the HAS engaged, is a degradation from previous evaluations, and is a shortcoming. Since all tests were conducted in winds of 8 knots or less, the HAS should also be evaluated in gusty wind conditions.

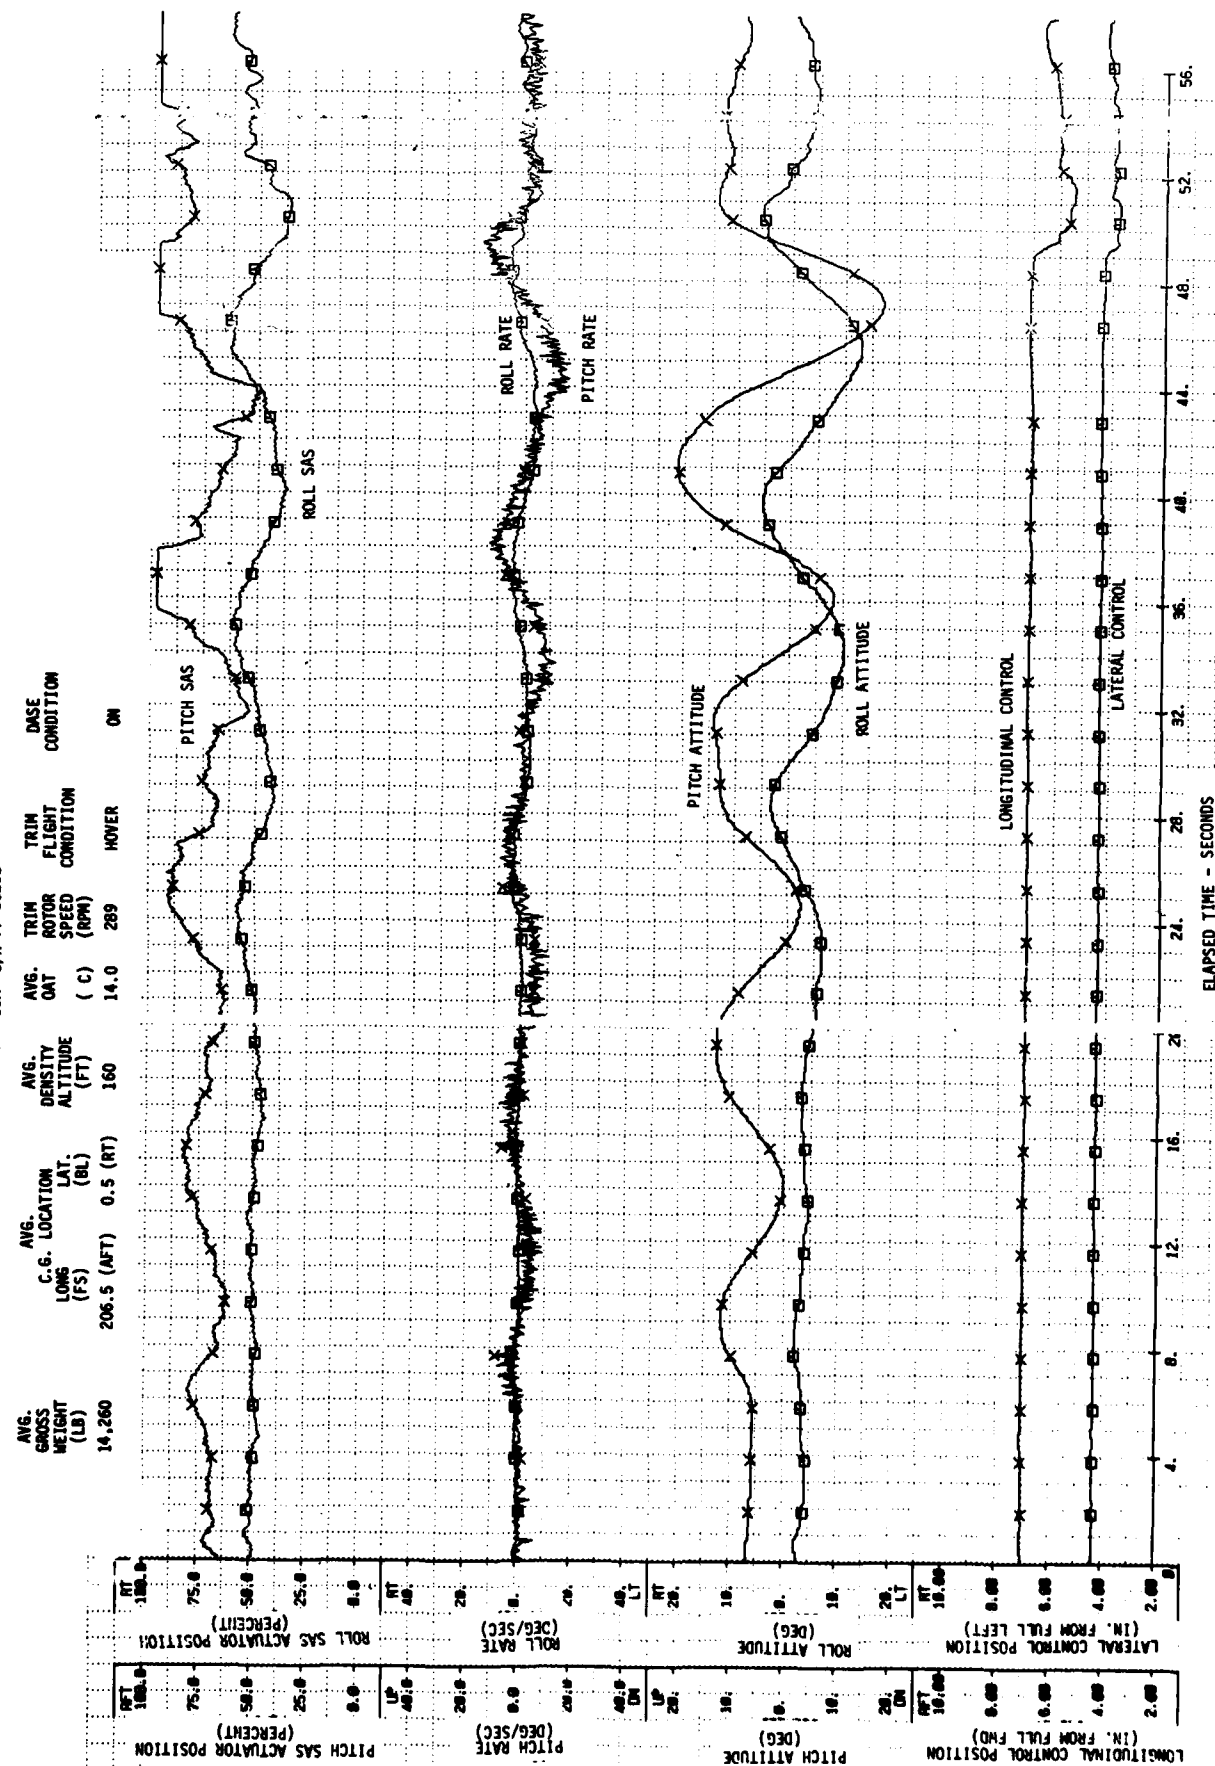
AVG. GROSS WEIGHT (LB)	AVG. C.G. LOCATION (FWD)	AVG. DENSITY ALTITUDE (FT)	AVG. QAT (C)	TRIM MOTOR SPEED (RPM)	TRIM FLIGHT CONDITION	DASE CONDITION
14,260	206.5 (AFT)	0.5 (RT)	14.0	289	HOVER	ON

FIGURE 23  
SIMULATED 3 AXIS DASE FAILURE  
YAH-64 USA S/N 77-23258

33. Single and multiple channel DASE failures were performed during flight with Attitude Hold ON and OFF and with HAS ON and OFF. Single channel failures were simulated by using the yaw, roll and pitch switches located on the DASE control panel. Multiple channel failures were simulated by depressing the DASE release switch on the pilot cyclic grip. It was found that a DASE failure resulted in uncommanded control inputs in all three axes because the SAS actuators were displaced from center. When the DASE failed (simulated by depressing the trim release switch) the SAS actuators immediately recentered causing an abrupt

uncommanded control input (fig. 23, app E). This condition is similar in abruptness and potentially of the same magnitude as an unmonitored hardover condition where the SAS actuator rapidly displaces from center, to either of its limits, and remains there. Previous evaluations included only monitored hardover tests, which were simulated electronically by rapidly displacing the SAS actuator from center, to either of its limits, and immediately returning the actuator to center. The monitored hardover test simulated the function of the DASE hardover monitor circuit (designed to prevent a hardover condition) but did not evaluate the abrupt recentering of an offset SAS actuator. Since the SAS actuators may also be displaced from center during HAS OFF operations (para 34), uncommanded control inputs may be a significant problem during NOE flight, confined area operations, operation in turbulence, IMC flight, flight using the PNVS as well as flight with the HAS engaged. Data obtained during controllability tests (para 16) show that uncommanded control inputs could produce rates of up to 25 degrees per second in pitch and 21 degrees per second in roll with an additional input in yaw. These rates would exceed the 10 degree per second maximum rate allowed by the system specification. Additionally, in the present configuration, it is possible to induce a condition equivalent to a three-axis hardover, with the failure of the Heading and Attitude Reference System (HARS). The magnitude of the hardover condition would be dependent upon the amount of SAS actuator displacement from center. Uncommanded control inputs caused by recentering of the SAS actuators, upon failure or disengagement of the DASE, may cause a potentially hazardous situation. Conditions capable of producing abrupt uncommanded control inputs should be further investigated and, if necessary, the DASE should be modified prior to reevaluation during A&FC, part 3.
